Aviatorilor Boulevard - Qualitative Tree Assessment

The study is presenting the results of the tree assessment survey carried out over a segment of Aviatorilor Boulevard - an important part of the Romanian green heritage which is also an existing green corridor that links two of the most important landscaped spaces of Bucharest: Kiseleff Park (one of Bucharest's first public gardens) and Herastrau Park (the largest urban park of the city). Beside more deeply inquiring the vegetation status - by adding several new analysis criteria - the study is presenting the outcomes in comparison with the results obtained in 2009 through another study conducted on the same area. The outputs revealed that meantime the overall state of the vegetation worsened although several new additions were made. The gathered data have enabled also the generation of a more accurate image regarding the vegetation's condition embedded within this site. The survey's structure allowed the formulation of some consideration toward the interventions needed in order to stop the vegetation decay and for the future rehabilitation of the ensemble.

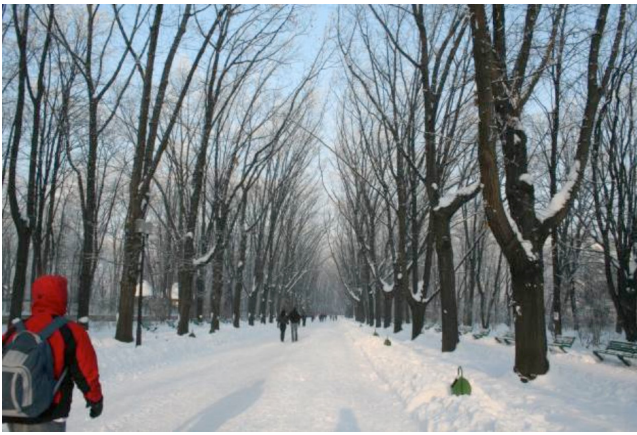
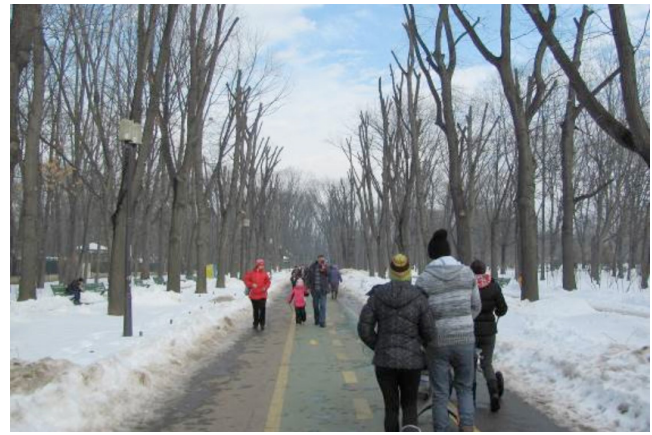
inflicting irreversible damages to urban trees in hasty actions, unsubstantiated on proper studies, only to be fined later by the National Environment Guard in a rather symbolical lanner because nothing else can be done in order to improve the situation (Fig. 1). Besides erratically spending the resources (financial, human, time, equipment), this "management" approach is also producing a rapid decay of urban green space.

Fig. 1 Images depicting the before (left) and after (right) situation generated by the “beautification” and “sanitation” interventions made by the local public administration in January 2014 upon the vegetation (*Quercus rubra* specimens) placed along one of the main entrances of Herastrau Park - Bucharest’s largest historic park; the cuttings were applied regardless of tree’s health, species, needs, etc.; at a later date, under community’s pressure, the National Environment Guard analysed the situation and decided that the intervention was made without suitable studies and administrative approvals, but the only measure that has been taken was to fine the administration with approx. 1000 EUR for destroying a main historic feature of the capital city of Romania (source: left photo - Alexandra Mihailciuc - before February 2014; right photo - Diana Culescu - February 2014)

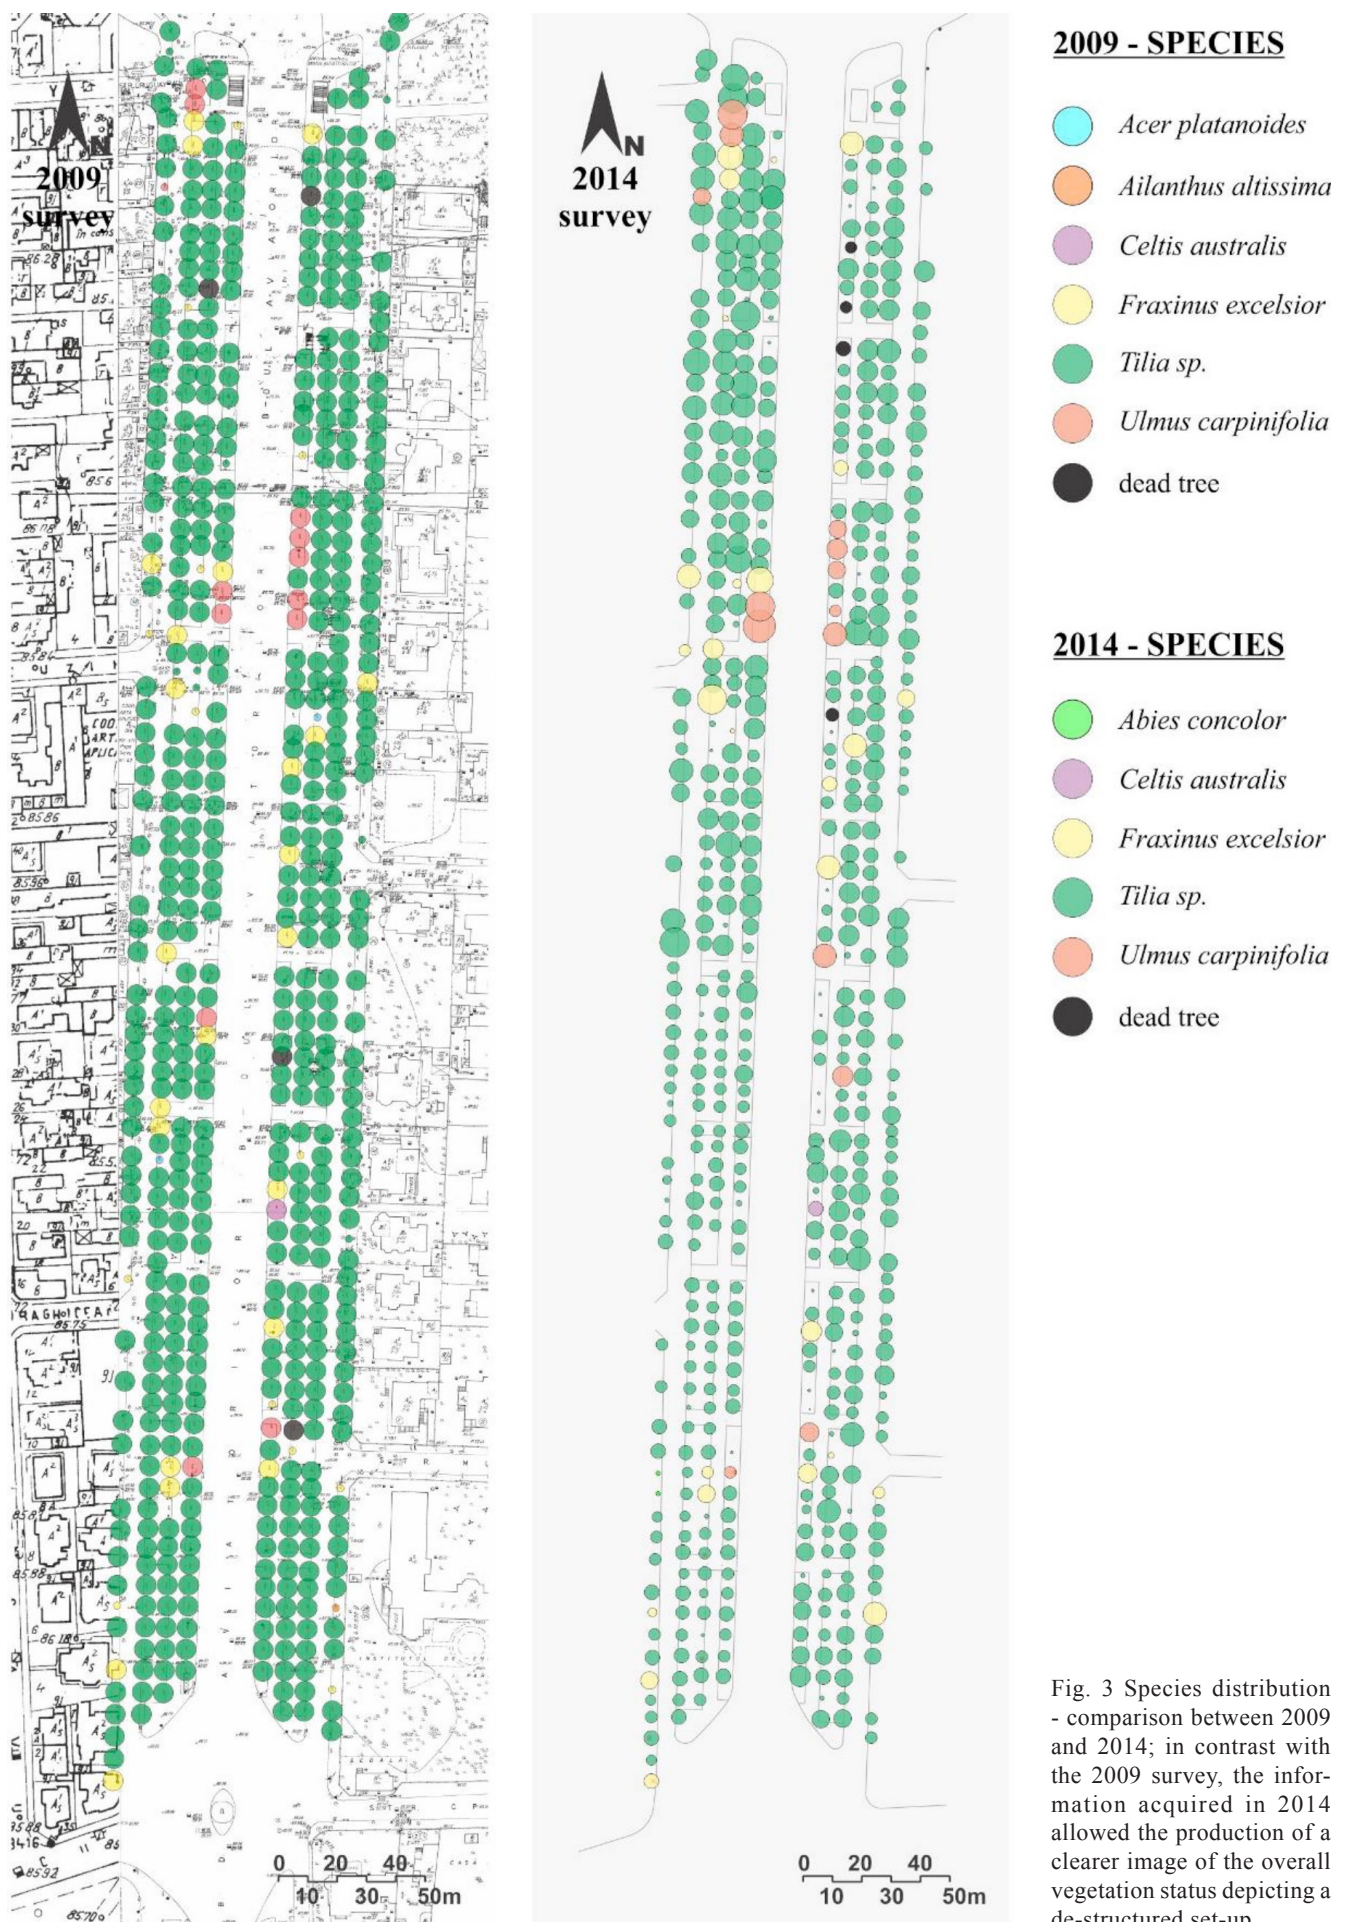
The specimens are in majority young trees (T), which did not yet reach even half of the dimensions characteristic for their species. Over 6% of the vegetation was framed within the newly planted trees (N) typology. The measurements taken for every specimen emphasizes this observation and the crown coverage (projected diameter) is illustrative for the overall de-structured appearance of the set-up (Fig. 3).

Fig. 3 Species distribution - comparison between 2009 and 2014; in contrast with the 2009 survey, the information acquired in 2014 allowed the production of a clearer image of the overall vegetation status depicting a de-structured set-up.

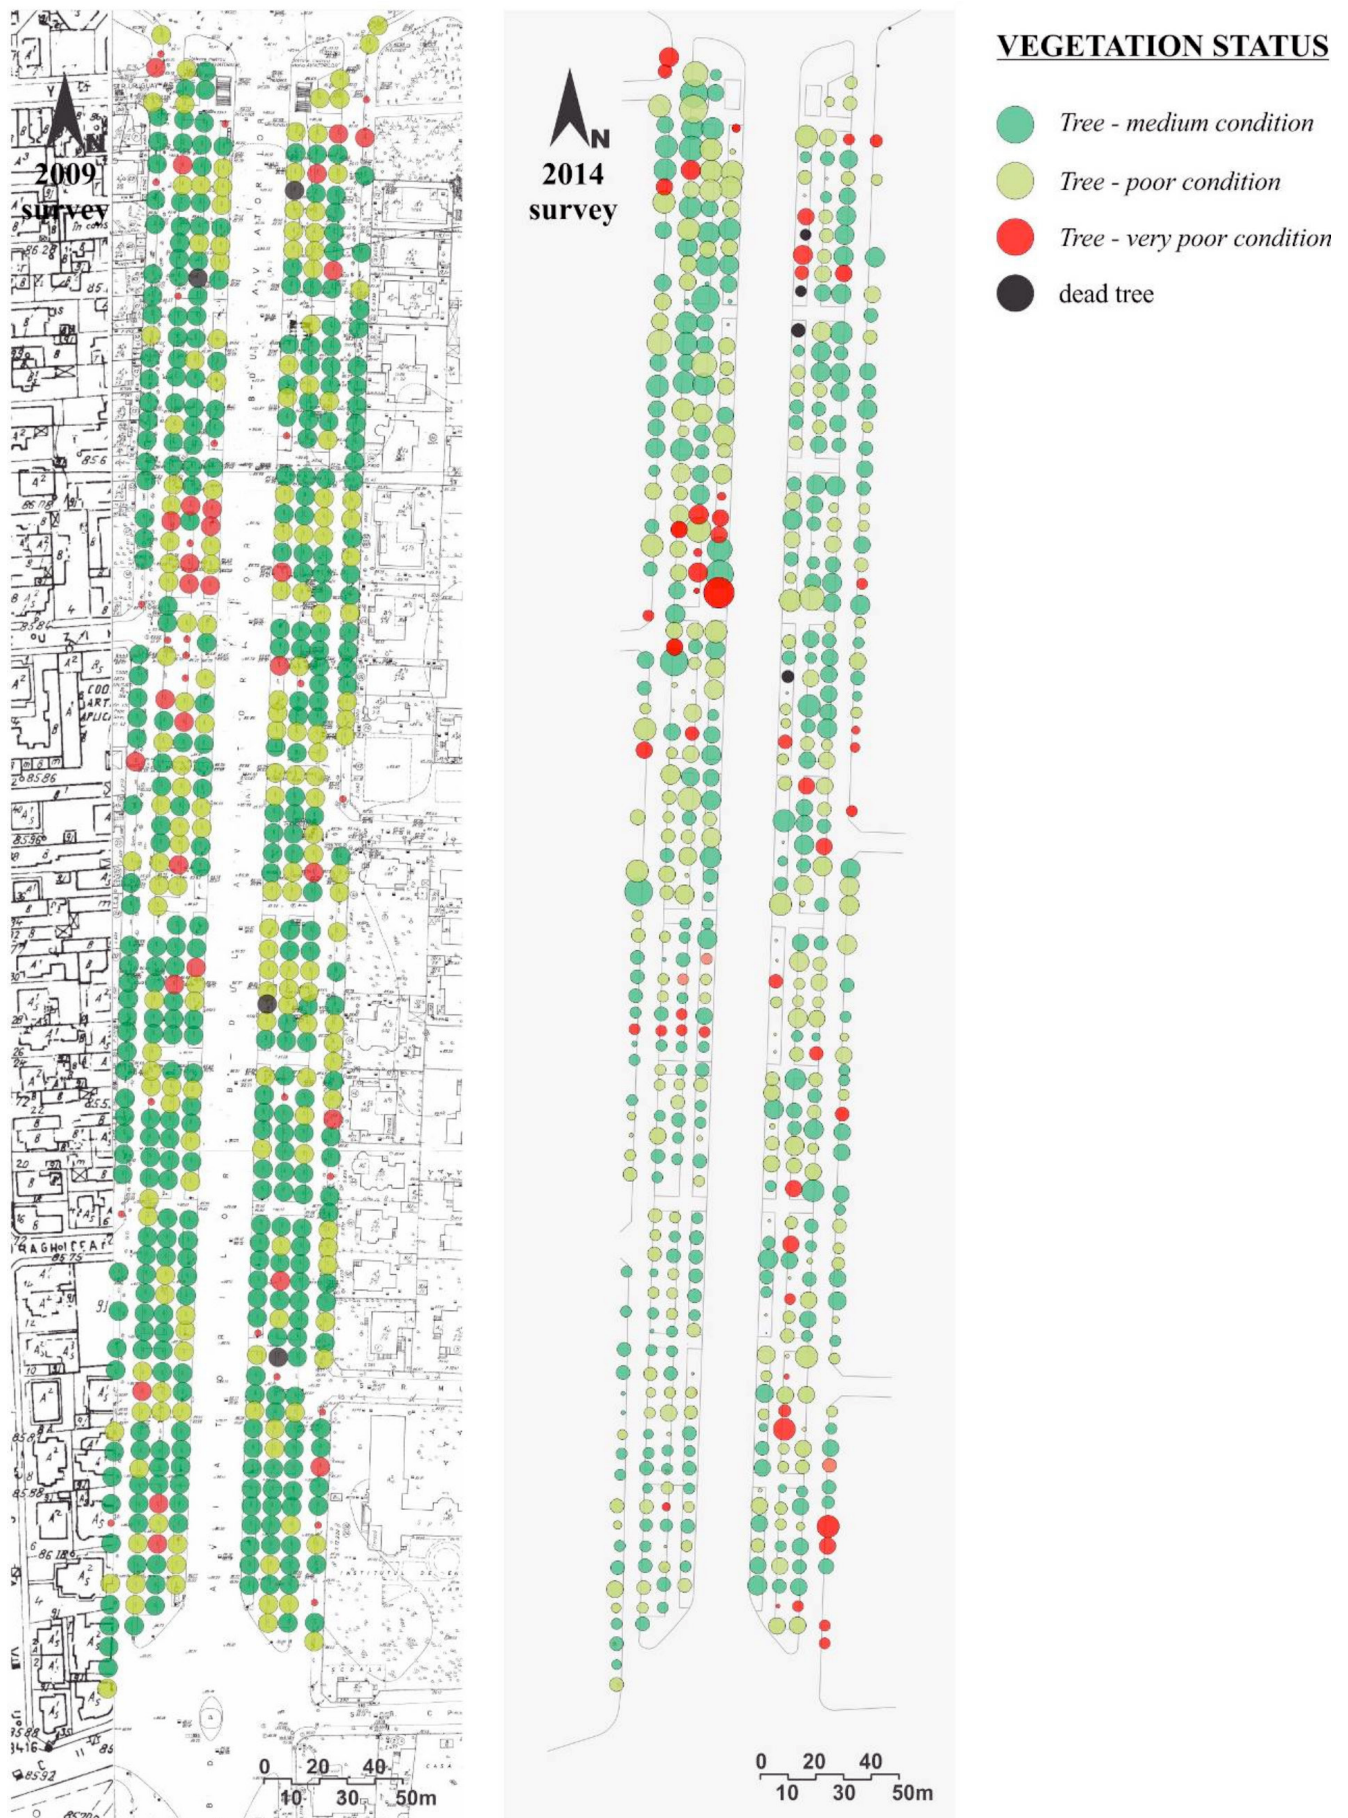
In terms of general condition, a decreasing of the vegetation's quality could be observed (Tab. 3; Fig. 4). Thus, the medium condition percentage shifted from 59% to 47%, and the number of specimens with a poor condition increased with 11% (from 31% to 42%). The very poor condition percentage increased with only 1% from the previous survey. There should be noted that no tree in excellent condition could be found within the

Fig. 4 Vegetation status - comparison between 2009 and 2014; the trees' depreciation can be better observed in relation with the crown dimension in the 2014 survey.
